# Plascoat PPA 571

## Optimising key assets in a harsh environment

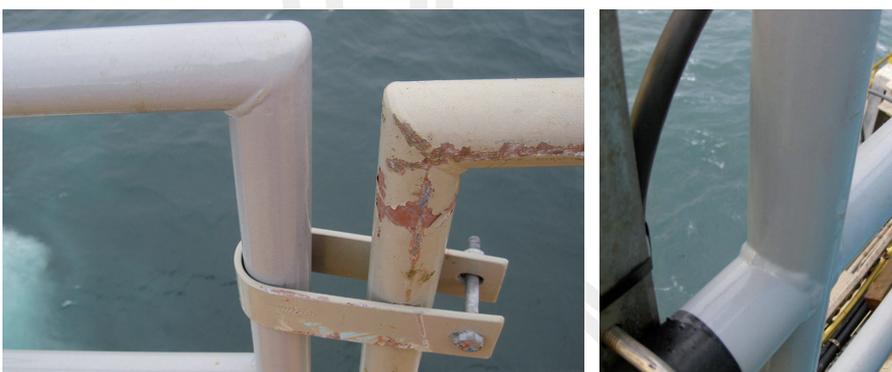
Over the years, one of the major energy, offshore and shipping operations in the North Sea has used a variety of methods for protecting its metal infrastructure. The photographs below show parts of a safety rail, both coated at the same time in 2010. One has been coated in liquid paint which has clearly cracked and flaked and is allowing corrosion of the metal beneath.

The other safety railing was coated in **Plascoat PPA 571**. The photograph clearly shows that this fusion bonded coating has far longer durability than liquid paint in hostile environments and provides long term protection against corrosion. **Plascoat PPA 571** forms a thick durable coating with excellent abrasion resistance. It does not chip or crack on impact, highly relevant on a rig where heavy components are being shifted around and where storms throw items against each other. There is no chance of penetration by water, gases or microbes and so degradation does not start underneath the surface as it so often does with liquid paint.

Both rails coated six years ago: Plascoat PPA 571 on the left hand rail, liquid paint on the right hand rail.
